Detection of Corrosion and Geometrical Anomalies Within District Heating Pipework Using High Resolution, Low Risk, Ultrasonic Inline Inspection Tools

By Jason Tuer (Quest Integrity) and Philippe Frery (Salines Energies Service – ENGIE Solutions)

Detection of Corrosion within District Heating Piping Using High Resolution, Low Risk, Smart Inline inspection tools at Salines Energies Services (ENGIE Solutions) – La Rochelle, France

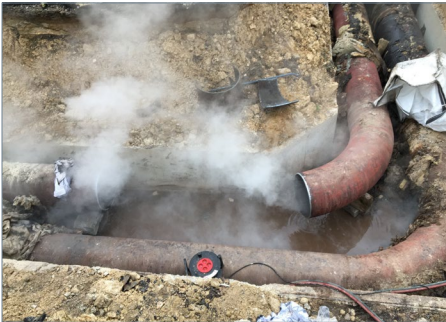
During the repair, the cause of the leak was identified as severe external corrosion resulting in a 'through wall' loss of containment.

Fig. 6 - Section of pipework removed following leak

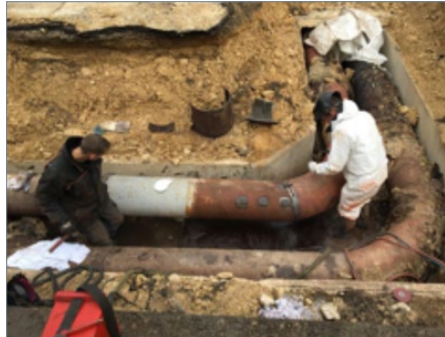
Fig. 7 – Finalization of repair using replacement pipe

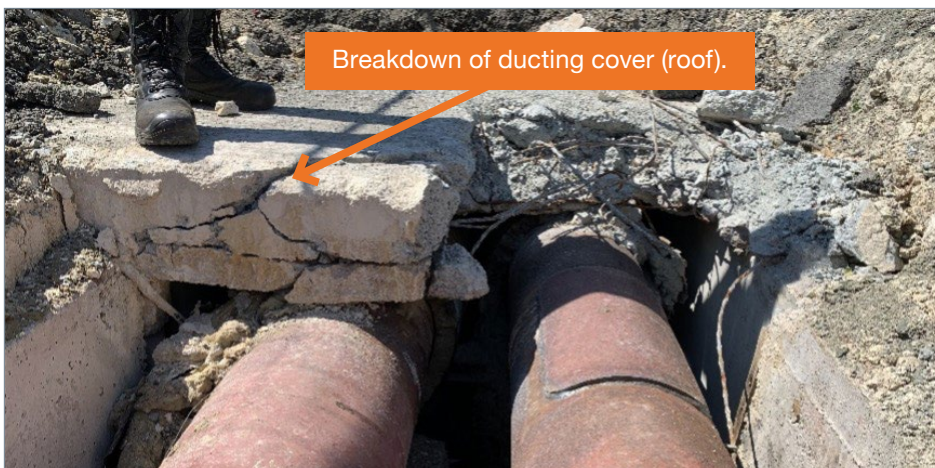
As often experienced within concrete ducted district heating networks, the cause of the corrosion (often referred to as the failure mechanism) was the result of a breakdown of the chamber cover (roof) (Figure 8). The damage to the cover allowed for water ingress into the chamber, saturating the insulation layer and instigating the onset of corrosion to the pipework.

Fig. 8 – Cross section of broken-down ducting cover enabling water ingress

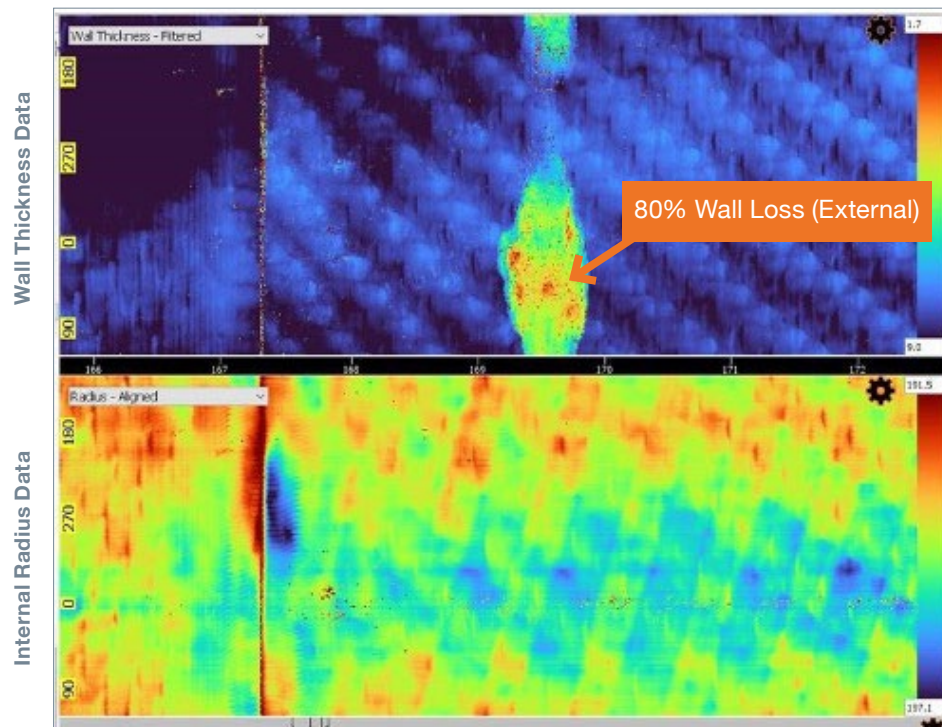
During the initial data review, one significant defect was detected and discussed during the close out meeting with SES. The defect was located 165m from the boiler plant within the return pipe and showed an external wall loss of 80 percent orientated at the 13:00HRS clock position within the pipework (Figure 20).

Fig. 20 – Quest InVista™ Inspection Data Indicating Significant External Wall Loss

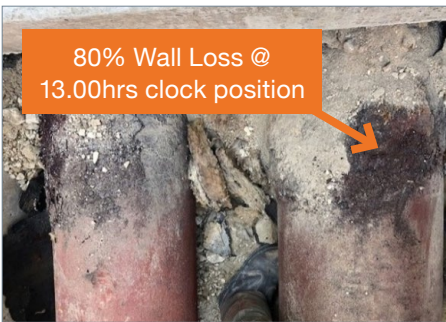
As demonstrated within Figure 23 below, the metal loss was visually confirmed once the degraded duct cover was removed.

Fig. 23 – Visual confirmation of defect following excavation.

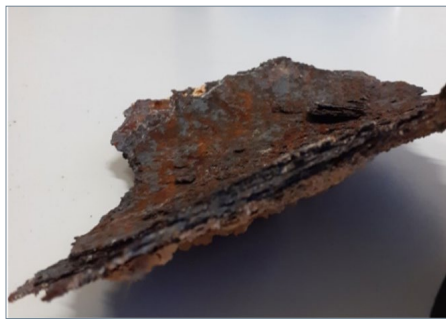
Fig. 24 – Section of detached corroded pipe wall removed.

Figure 24 shows corroded piping material recovered by hand from the excavation location. SES immediately started the plan of repair and awaited the final reports to be compiled and submitted by Quest Integrity.

Of extreme significance is the fact that this threat was on the return line close to the boiler plant, effectively being at the opposite position to the original leak location. Without the application of the Quest Integrity InVista™ tool, this critical defect and threat to future operations would have remained undetected.

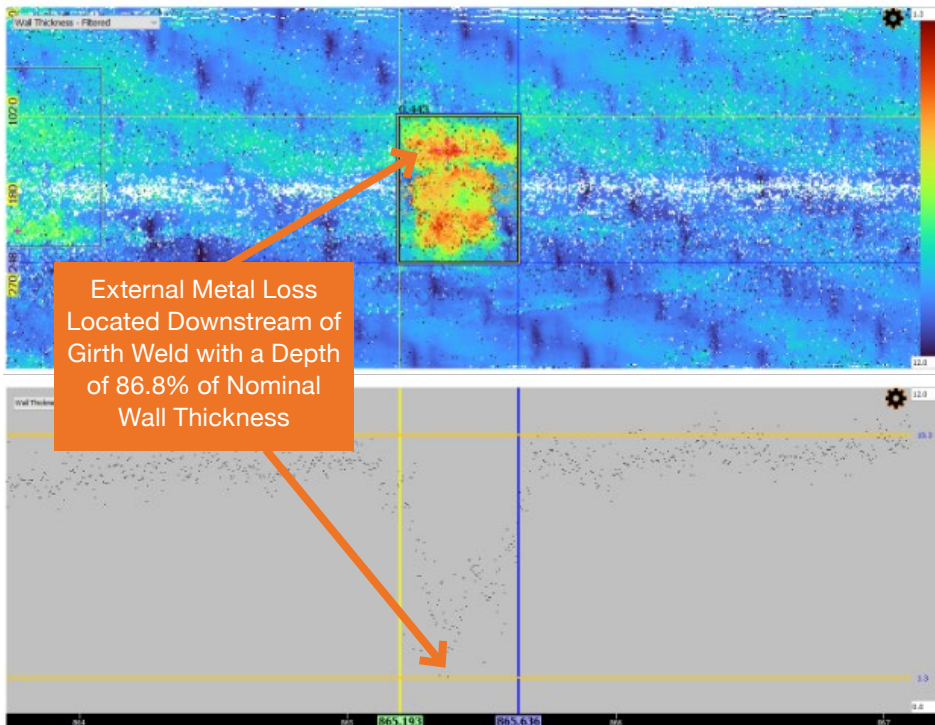
- + Eighty-nine (89) external metal loss anomalies with a depth greater than 15 percent were identified in the inspection data.
- + Based on a nominal wall thickness of 10.31 mm (0.406 inches), this metal loss corresponds to an 86.8 percent wall loss.

Fig. 26 - C-Scan and B-Scan of External Metal Loss

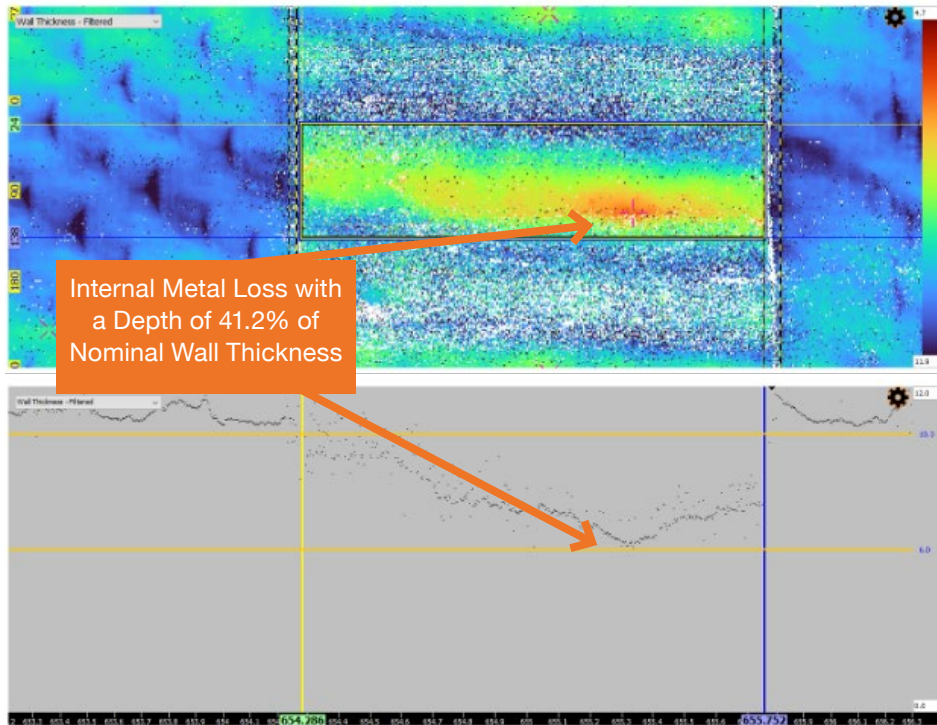
- + Two (2) internal metal loss anomalies with a depth greater than 15 percent were identified in the inspection data.
- + Based on a nominal wall thickness of 10.31 mm (0.406 inches), this metal loss equates to a 41.2 percent wall loss. This internal metal loss anomaly is a wall thickness variation in a bend.

Fig 27 - C-Scan and B-Scan of Internal Metal Loss

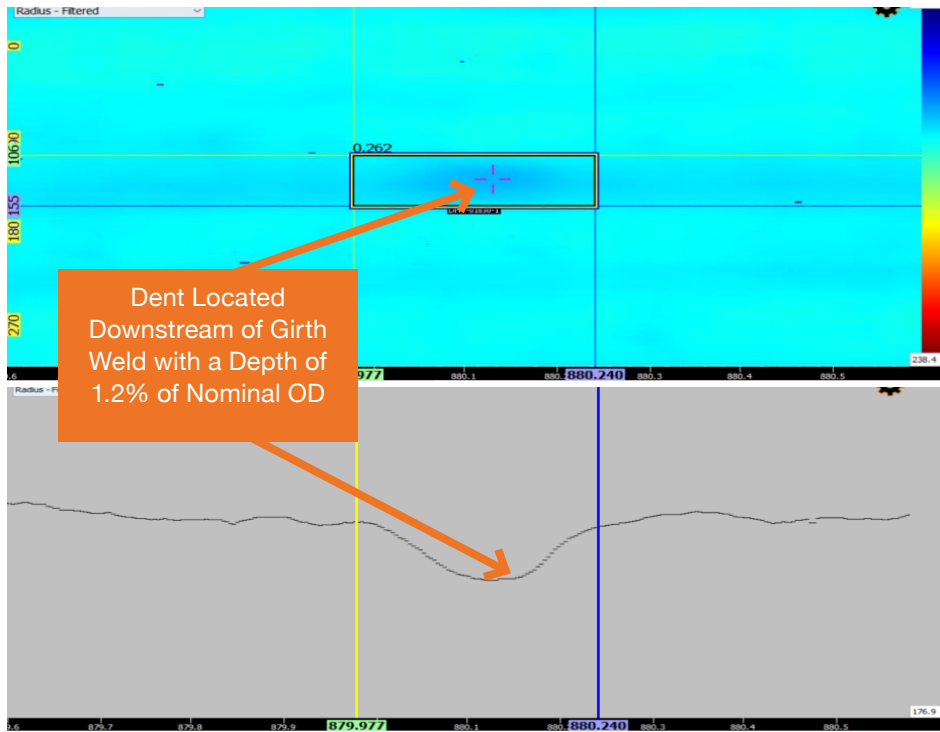
One (1) dent with depth greater than or equal to 1 percent of the nominal OD was identified in the inspection data. The maximum depth was 1.2 percent of the nominal OD and the deepest point of deformation is located at 880.13 m (2,887.56 ft.) with an orientation of 4:17 O'clock (Figure 28).

Fig. 28 -C-Scan, B-Scan, and Cross-Section of Dent

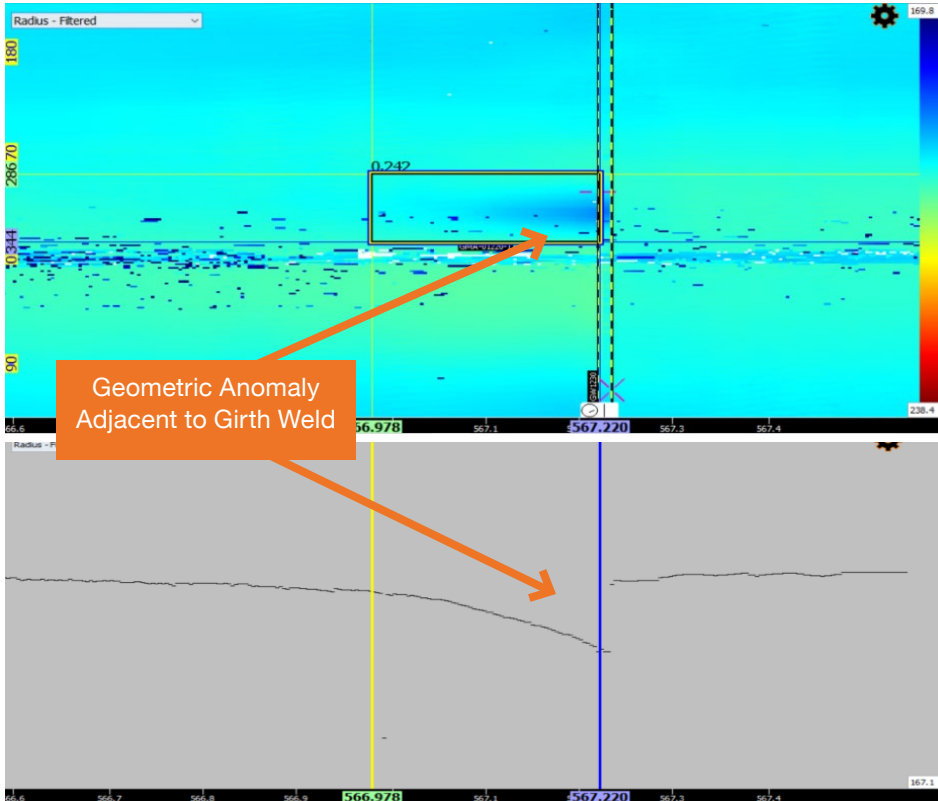
- + One (1) geometric anomaly was identified in the inspection data.
- + The feature is adjacent to a girth weld located at 567.22 m (1,860.97 ft.) (Figure 29). This anomaly is a possible weld misalignment.

Fig. 29 - C-Scan and B-Scan of Geometric Anomaly

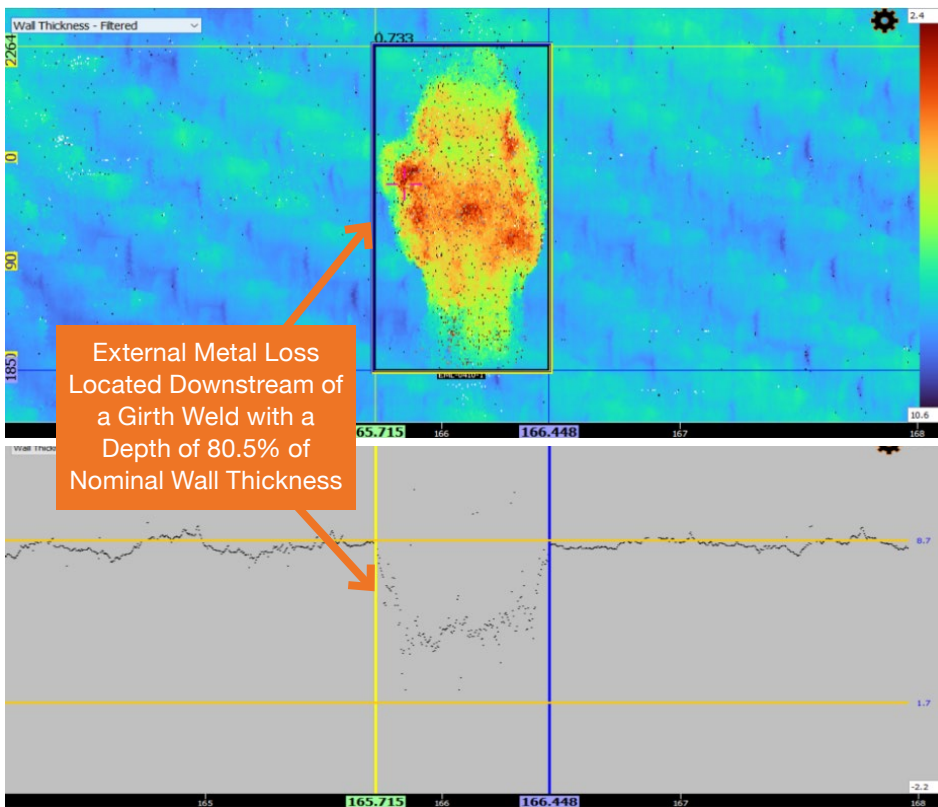
- + Forty-eight (48) external metal loss anomalies with a depth greater than 15 percent were identified in the inspection data.
- + Based on nominal wall thickness of 8.74 mm (0.344 inches), the deepest metal loss corresponds to an 80.5 percent wall loss anomaly.

Fig. 30 - C-Scan and B-Scan of External Metal Loss
