Detection of Corrosion Within District Heating Piping Using High Resolution, Low Risk, Smart Inline Inspection Tools

Case Study

In the winter of 2020, external corrosion led to a leak and an unexpected interruption of service within the district heating network of La Rochelle operated by an Engie Solutions Company - Salines Energies Services (SES).

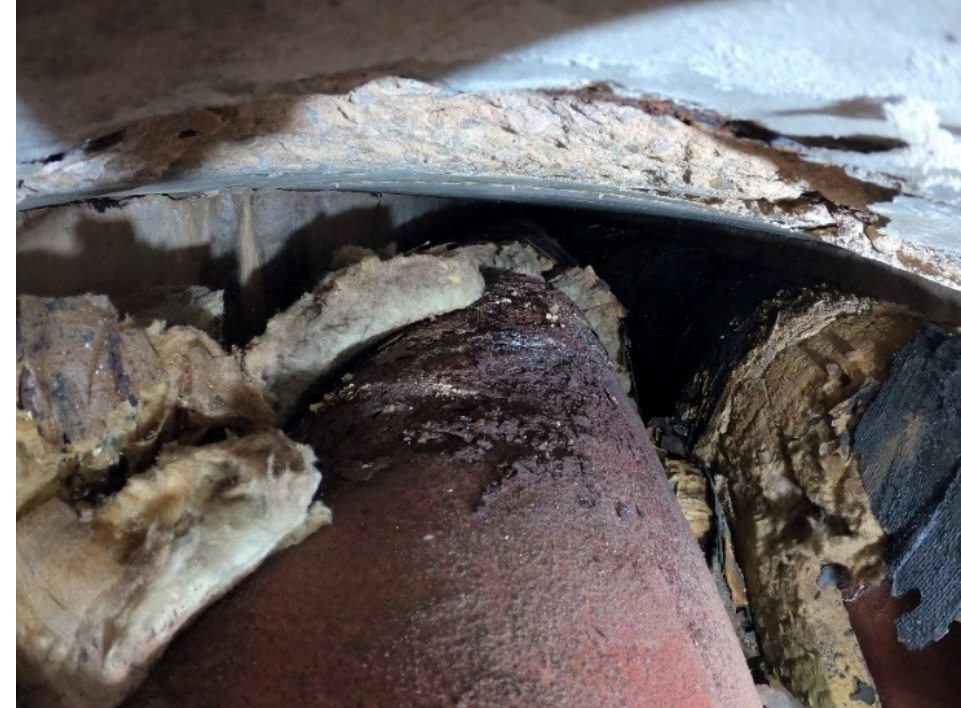
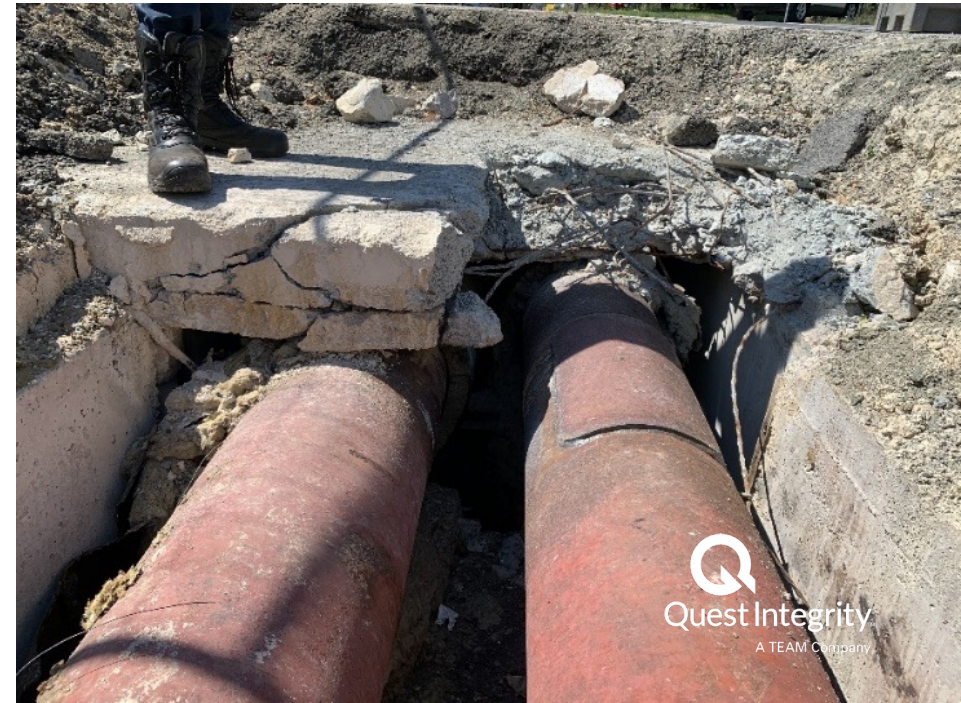
Cause of the Corrosion (Damage Mechanism)

Breakdown of the ducting cover allowed ingress of water/salt water to enter the chamber from above.

Soaking of the rockwool insulation resulted in consistent saturation of the pipework leading to the onset of external corrosion and a subsequent through-wall leak.

The leak occurred in original piping situated approximately 1km (0.625 miles) downstream from the boiler plant within the feeder pipe just prior to a transition from original to upgraded pipe.

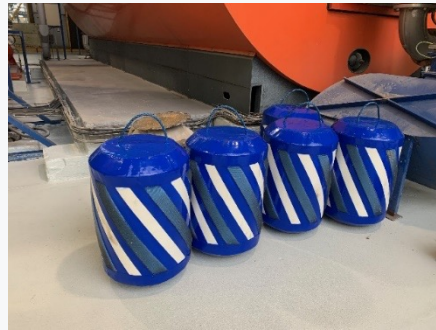
Before Use

Bi-directional Medium Density Spiral Wire Brush
Pipework Cleaning Tool

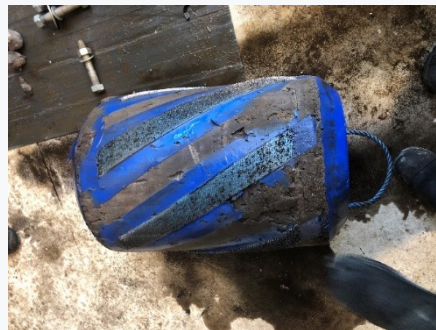
After Use

Condition evaluation
confirmed go-ahead for
InVista™ Inspection Tool

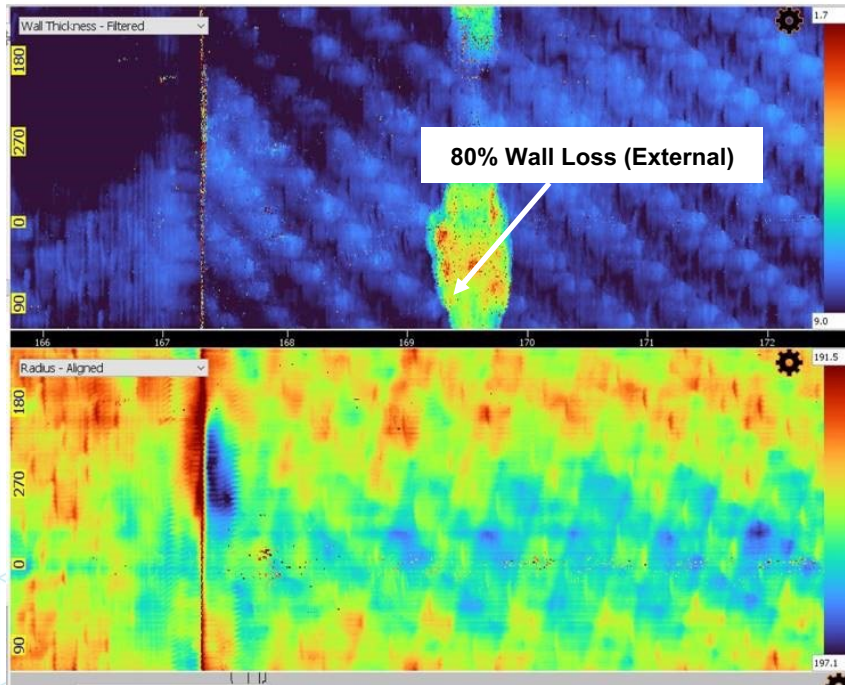
Onsite Inspection Results

– Immediate Threat Identified

**Return Pipework –
165m From Boiler House**

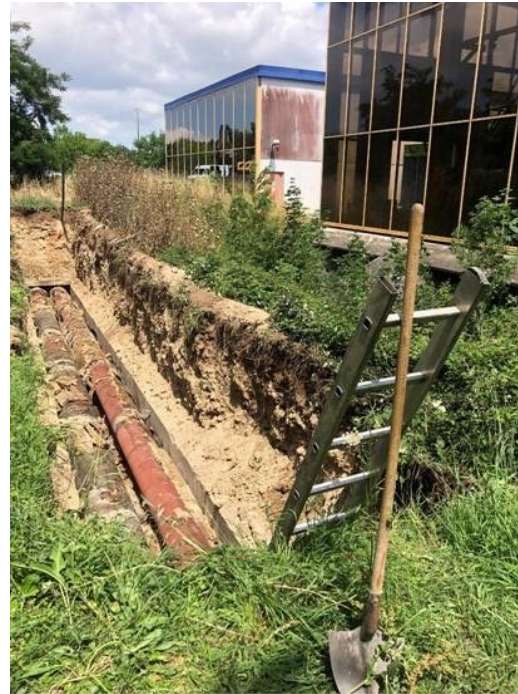
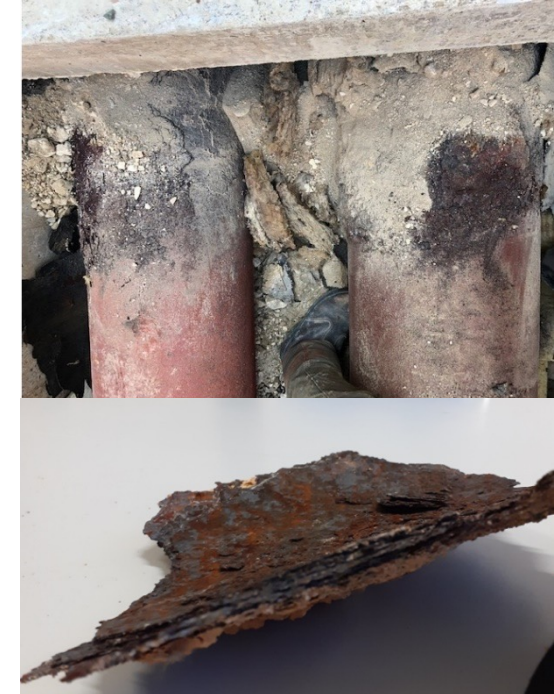
Excavation

**Corrosion Located /
Physically Recovered**

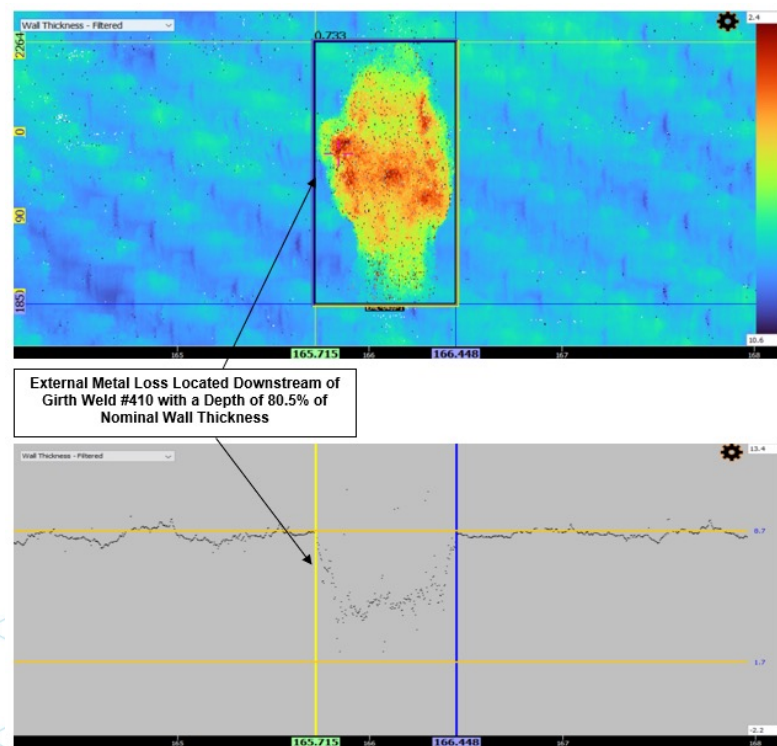
External Corrosion

- + Five external metal loss defects between 70% & 80% to be addressed for remediation as soon as possible.
- + Two external metal loss defects within the return pipework to be considered as borderline threats.

Figure 1. C-Scan and B-Scan of External Metal Loss EML-0410-1
