Detection of Corrosion and Geometrical Anomalies Within District Heating Pipework Using High Resolution, Low Risk, Ultrasonic Inline Inspection Tools

By Jason Tuer (Quest Integrity) and Philippe Frery (Salines Energies Service – ENGIE Solutions)

Detection of Corrosion within District Heating Piping Using High Resolution, Low Risk, Smart Inline inspection tools at Salines Energies Services (ENGIE Solutions) – La Rochelle, France

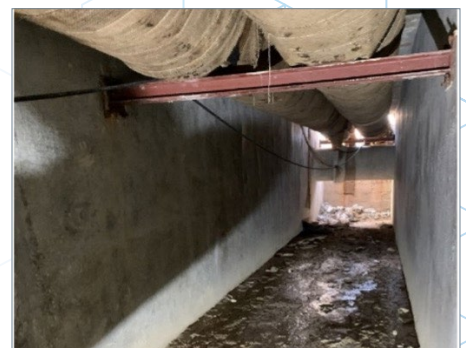
Fig. 5 – Feeder and return pipes supported within concrete channel

Following an unexpected interruption of service in the winter of 2020 due to a major water leak, it was concluded during the emergency repair work that a breakdown of the concrete ducting allowed underground water to infiltrate the system, causing severe external corrosion of the main pipework. Although the repair recovered service, it raised the question as to whether additional corrosion cells were present and possibly growing at different locations and with similar or possibly worse severity.

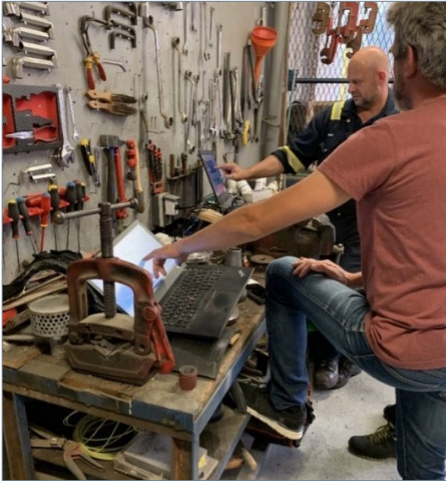
Fig. 21 – Quest Integrity & SES Personnel Pinpointing Defect

Quest Integrity and SES were immediately able to align the data within the SES GPS system to pinpoint the location of the 80 percent metal loss defect. Due to the location of the defect being near the boiler house and on land belonging to SES, an excavation of the lines at the stipulated location was completed overnight.

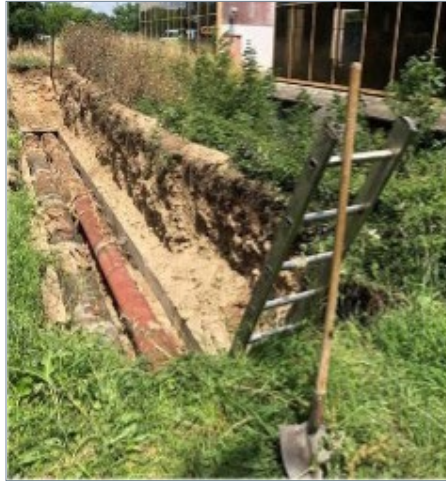
Fig. 22 – Excavation Trench

As demonstrated within Figure 23 below, the metal loss was visually confirmed once the degraded duct cover was removed.

Figure 24 shows corroded piping material recovered by hand from the excavation location. SES immediately started the plan of repair and awaited the final reports to be compiled and submitted by Quest Integrity.

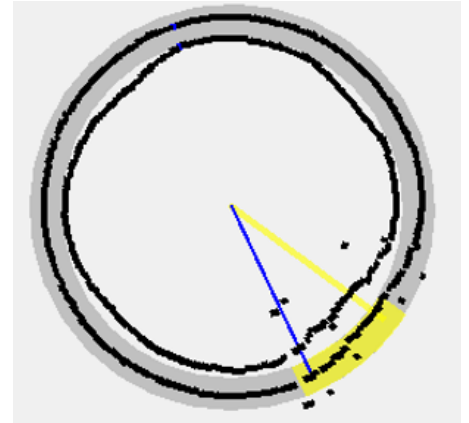
Fig. 29 - C-Scan and B-Scan of Geometric Anomaly

- + One (1) geometric anomaly was identified in the inspection data.
- + The feature is adjacent to a girth weld located at 567.22 m (1,860.97 ft.) (Figure 29). This anomaly is a possible weld misalignment.
